Central School  
29 Massaco Street  
Simsbury, Ct.

CENTRAL SCHOOL  
29 MASSACO STREET  
SIMSBURY, CT  
2021  
KEY TO PICTURE LOCATIONS

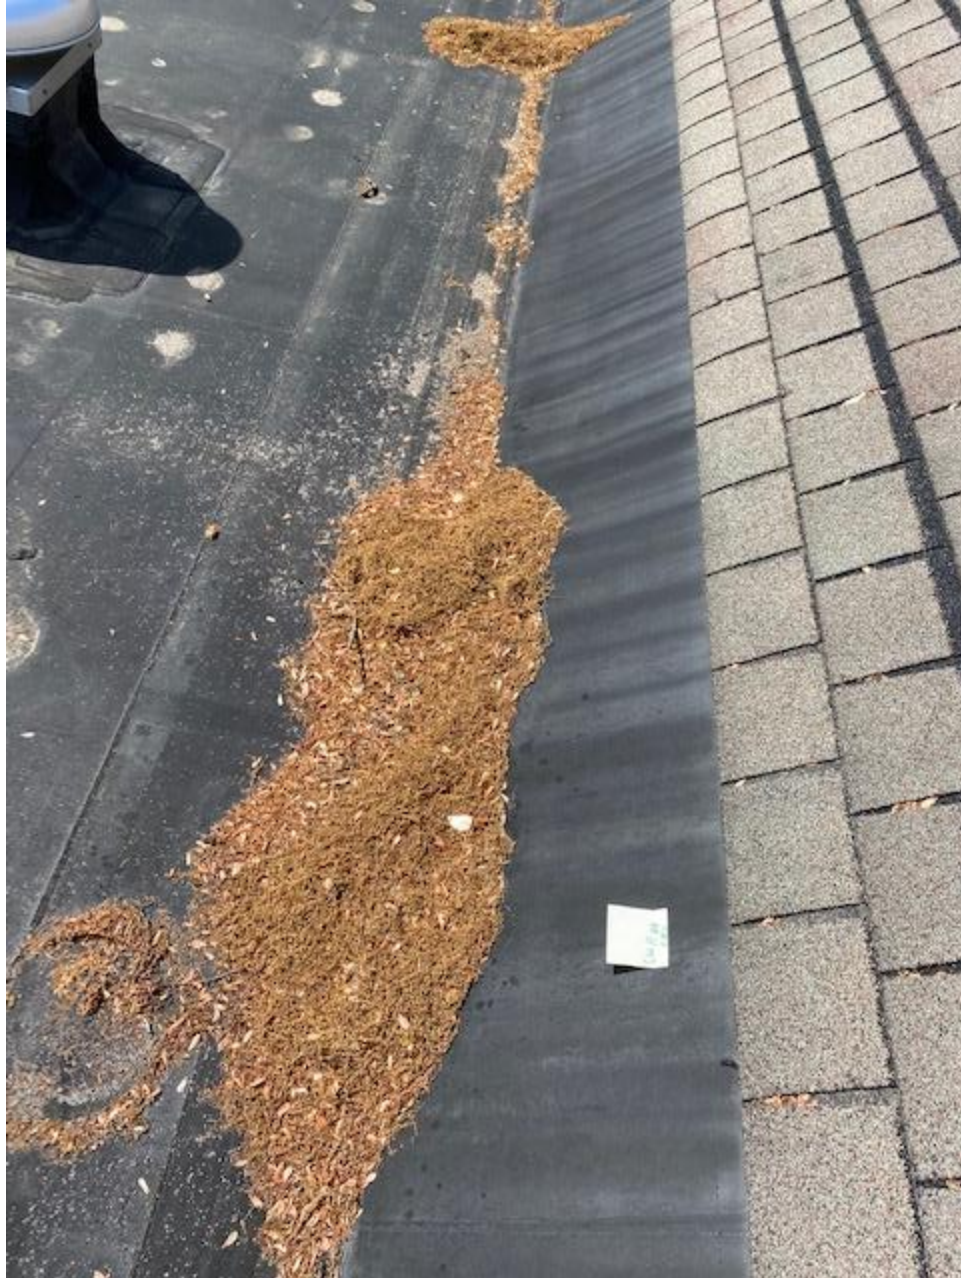
**CENTRAL SCHOOL PICTURE #3**  
SECTION B – DEBRIS REMOVAL

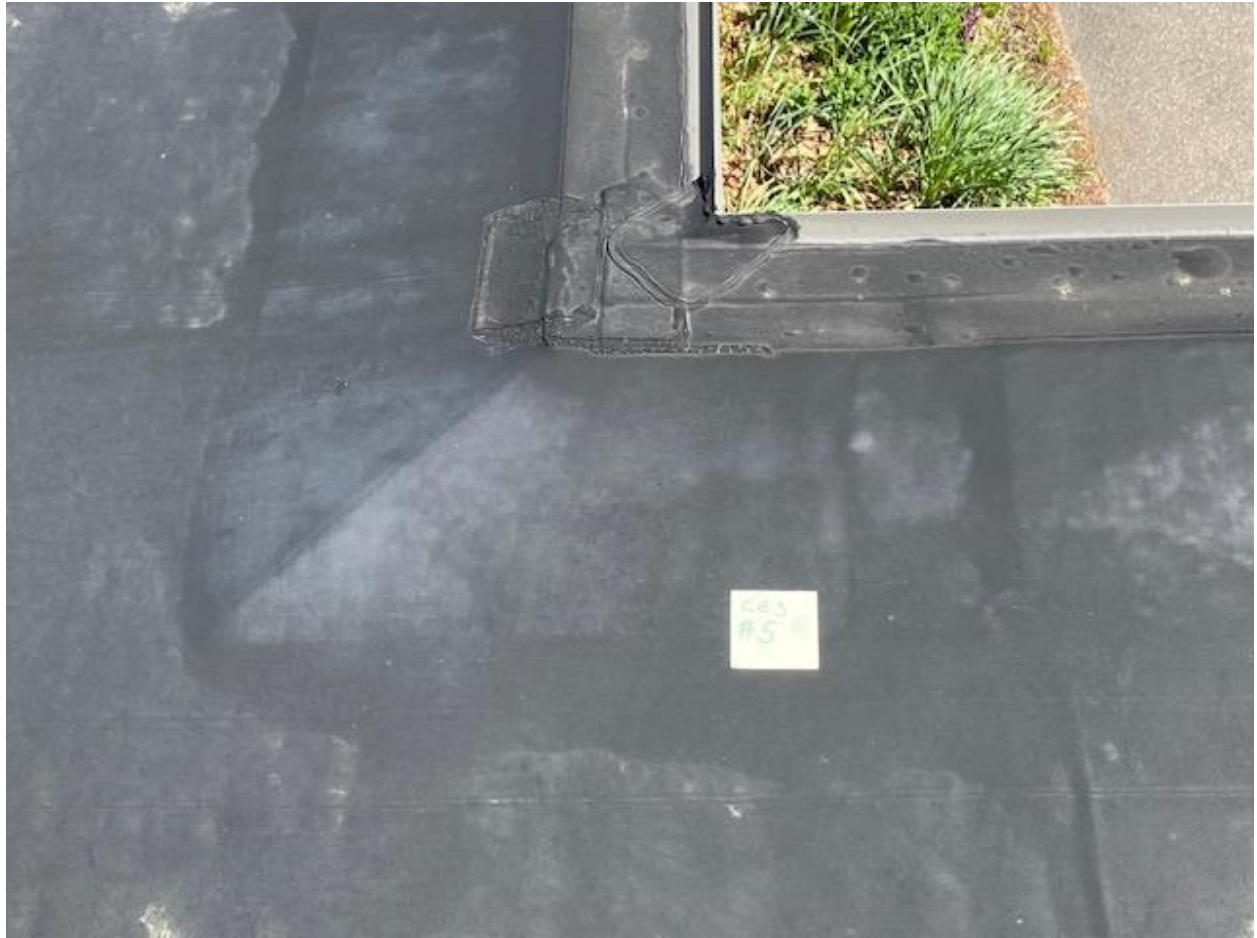
EPDM Roof Areas: Section B = Fair Condition (Please refer to Pictures #5, #6, #9 and #17).

**CENTRAL SCHOOL PICTURE #5**  
SECTION B – EPDM ROOF FAIR CONDITION

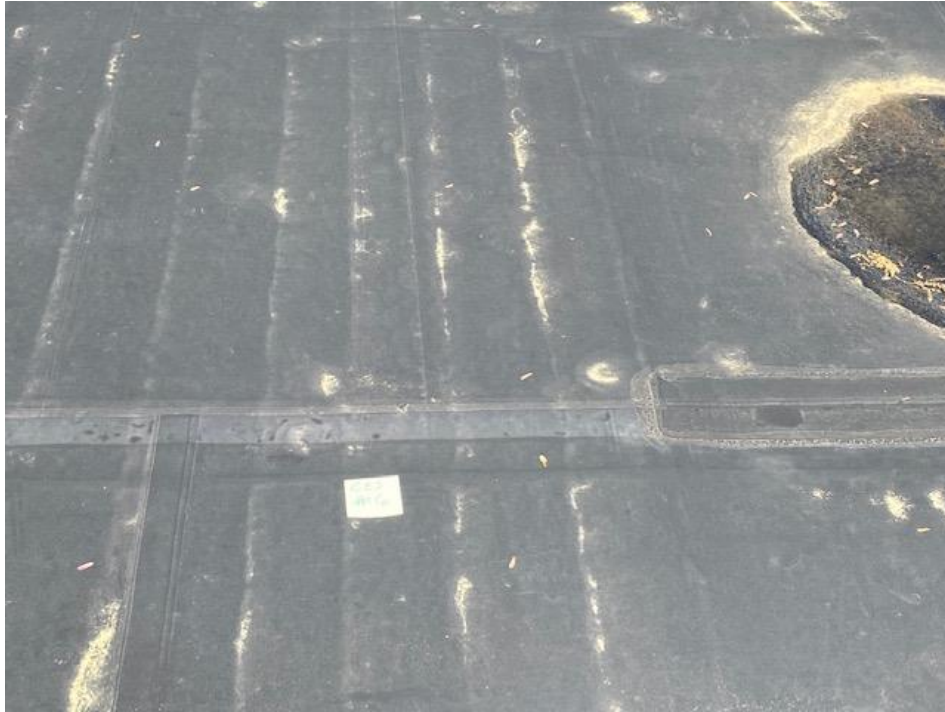
**CENTRAL SCHOOL PICTURE #6**  
SECTION B – EPDM ROOF FAIR CONDITION

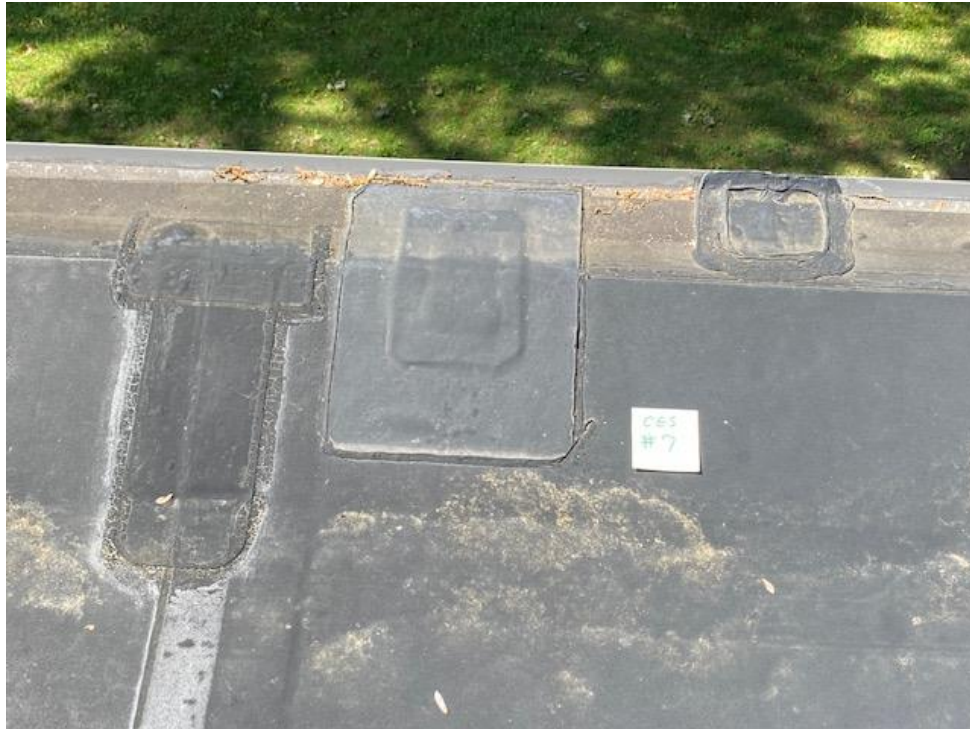
- There are multiple missing shingle tabs on Section A that should be replaced (Please refer to Pictures #8, #15, #16, #18 and #36).
- There are missing H&R shingle caps from the Southwest ridge (Please refer to Picture #29) and from the North/South ridge of Section I that should be replaced (Please refer to Picture #32).
- There is debris on some sections of roof and in some gutters that should be removed (Please refer to Pictures #3, #11-#13 and #19).
- There is split at the edge, a hole at the roof transition and a delaminated roof patch at section B that should be repaired (Please refer to Pictures #7, #10 and #14).

**CENTRAL SCHOOL PICTURE #7**  
SECTION B – SPLIT AT SOUTH EDGE

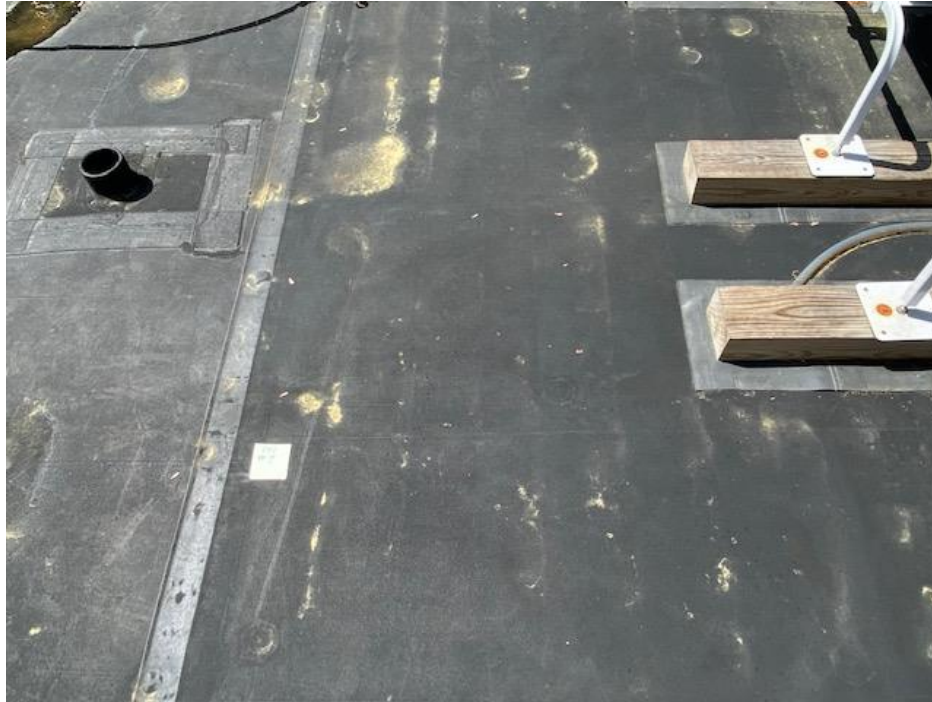
**CENTRAL SCHOOL PICTURE #9**  
SECTION B – EPDM ROOF FAIR CONDITION

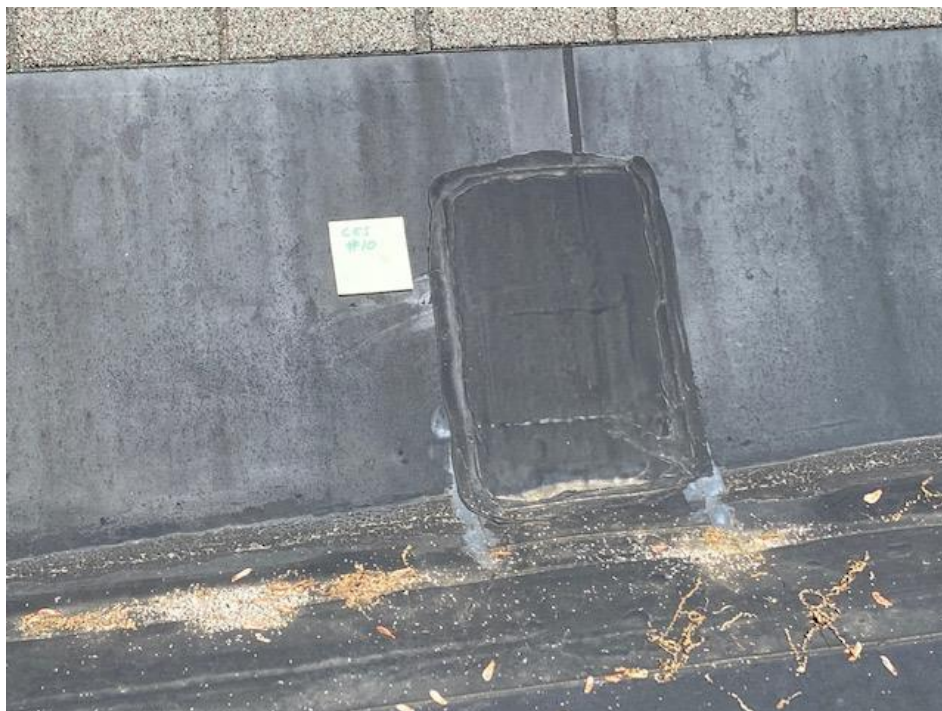
**CENTRAL SCHOOL PICTURE #10**  
SECTION B – HOLE AT A-B TRANSITION

1. Replace the missing shingle tabs on Section A (Refer to Pictures #8, #15, #16, #18 and #36).
2. Replace the missing H&R shingle caps from the Southwest ridge (Refer to Picture #29) and from the North/South ridge (Refer to Picture #32).
3. Clean up and dispose of all debris from the roof and gutters (Refer to Pictures #3, #11-#13 and #19).
4. Repair the split at the South edge of Section B with five-inch QuickSeam membrane set in Firestone QuickPrime primer (Refer to Picture #7).
5. Remove the fastener that caused the hole at the roof transition of Sections A & B with five-inch QuickSeam membrane set in Firestone QuickPrime primer (Refer to Picture #10).

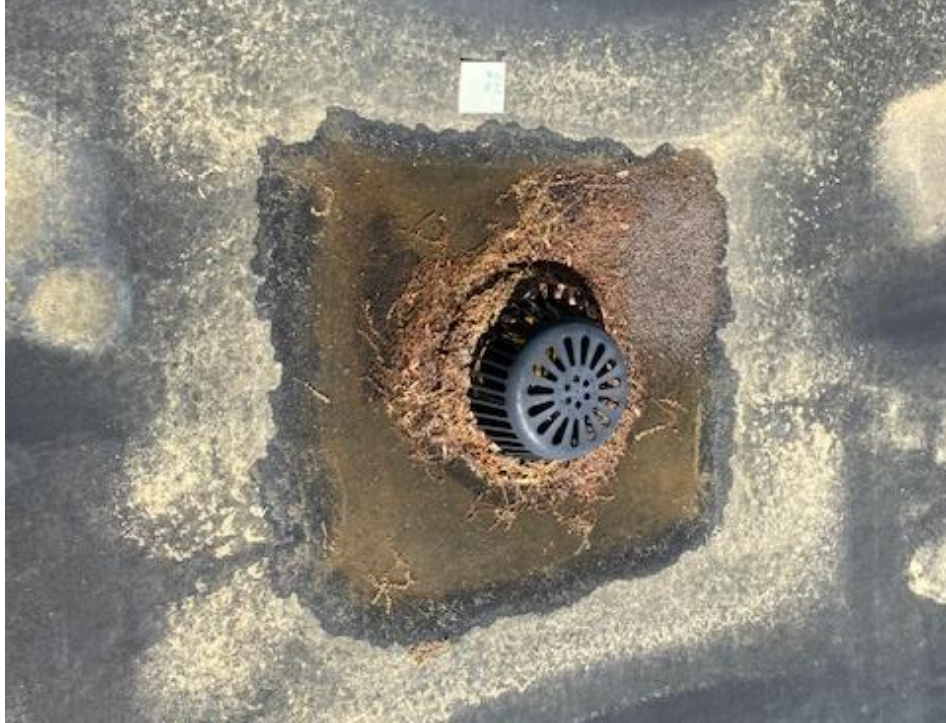
**CENTRAL SCHOOL PICTURE #12**

SECTION B – DEBRIS REMOVAL

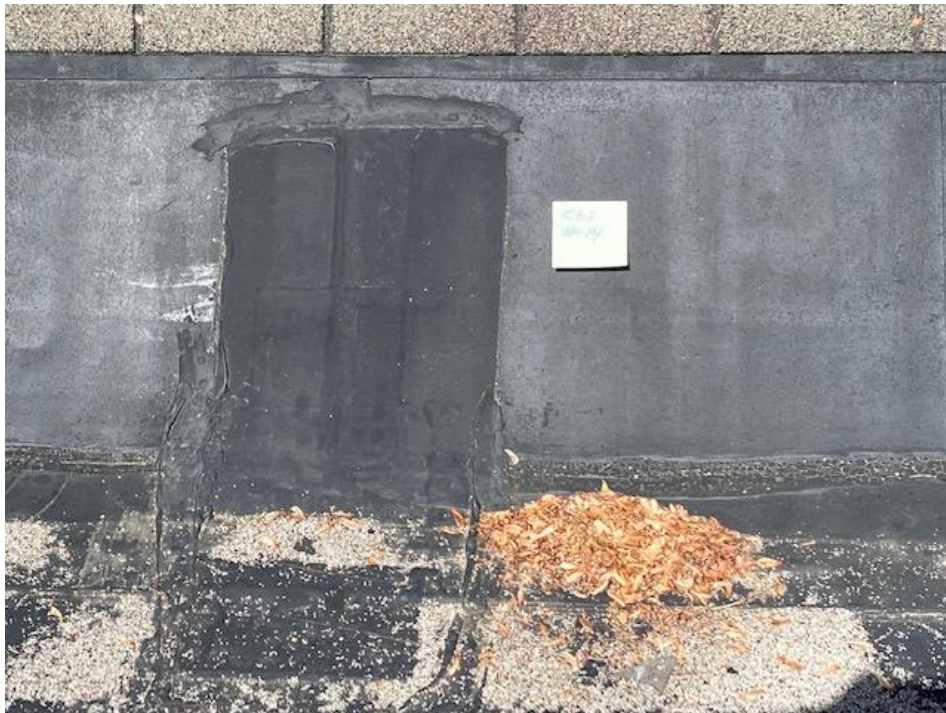
**CENTRAL SCHOOL PICTURE #14**

SECTION B – DELAMINATED ROOF PATCH

6. Reseal the delaminated roof patch at section B that should be repaired (Refer to Picture #14).

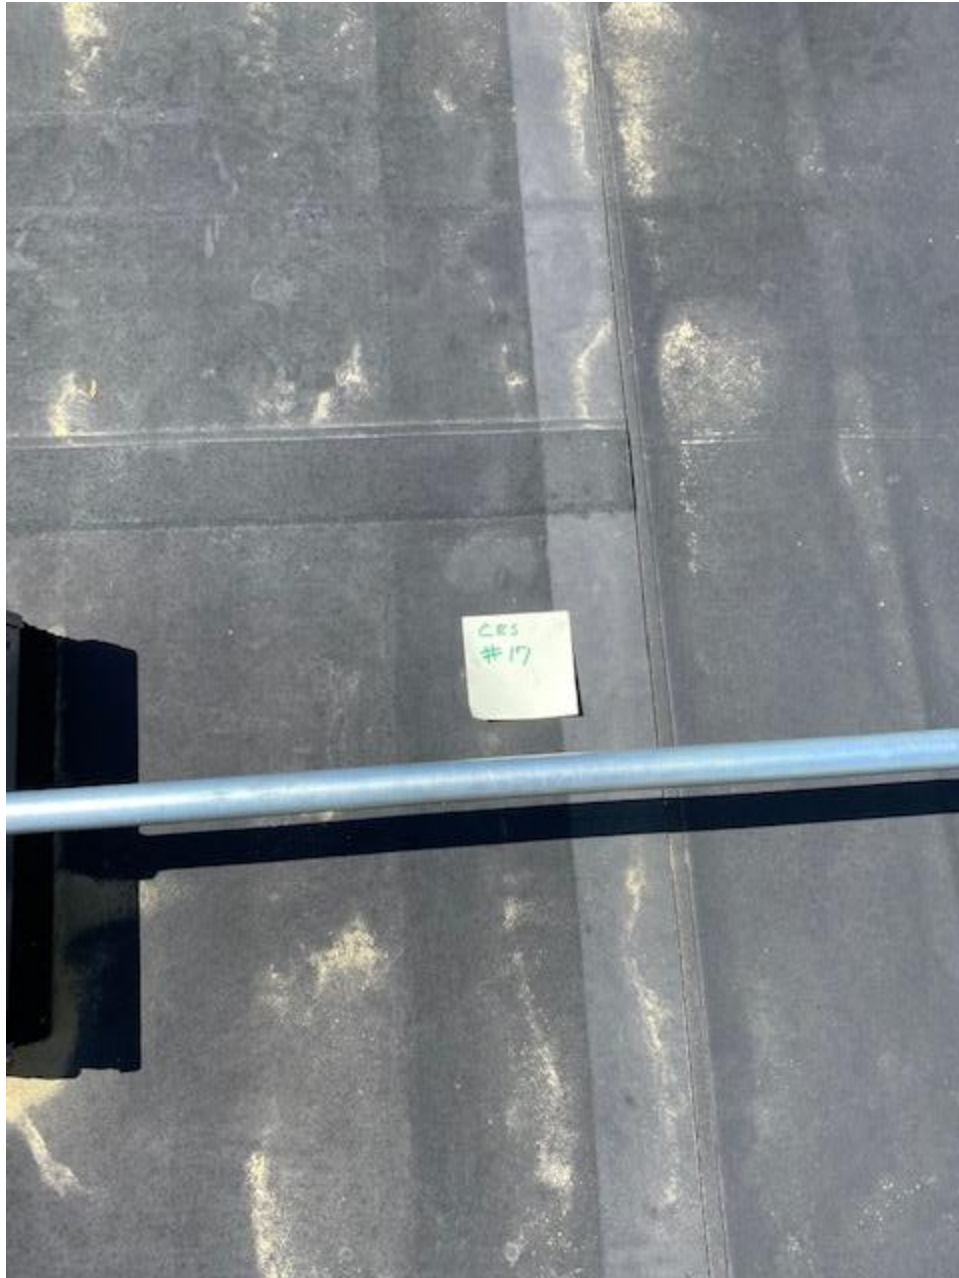
**CENTRAL SCHOOL PICTURE #17**  
SECTION B – EPDM ROOF FAIR CONDITION
